**Advancement in the Area of Intrinsically
Locatable Plastic Materials**

CAAP Final Report

Date of Report: September 29, 2017

Prepared by: West Virginia University, Constructed Facilities Center (WVU-CFC)

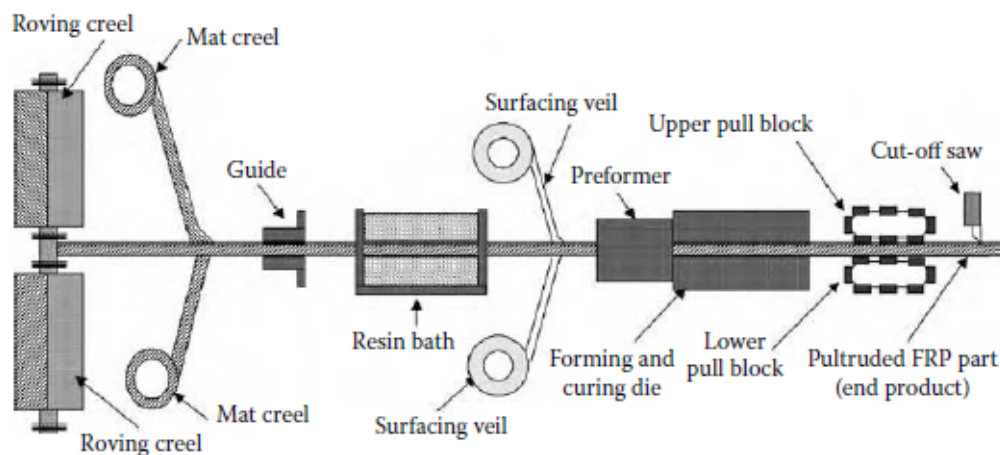
The process of pultrusion involves the pulling of fiber fabrics or fiber rovings through a resin bath and heated die. The fibers are first pulled from creels and run through a resin bath, which could contain wetting agents, fillers, catalysts, accelerators, and pigments. These admixtures affect the curing time, cost, and structural properties of the sections. The fibers are then shaped into a variety of sections by guides along the length of the machine. The fibers are then fed into the heated die, which initiates the cure. After passing through the die, the section is allowed to cool and then is cut to specified length. The output of a pultrusion machine is between 1 and 5 linear feet per minute; however, the throughput speed can be higher depending on the shape being pulled through the die. (GangaRao et al. 2007). **Error! Reference source not found.** below shows a typical configuration of a pultrusion machine.

Figure 2-1: Pultrusion Machine

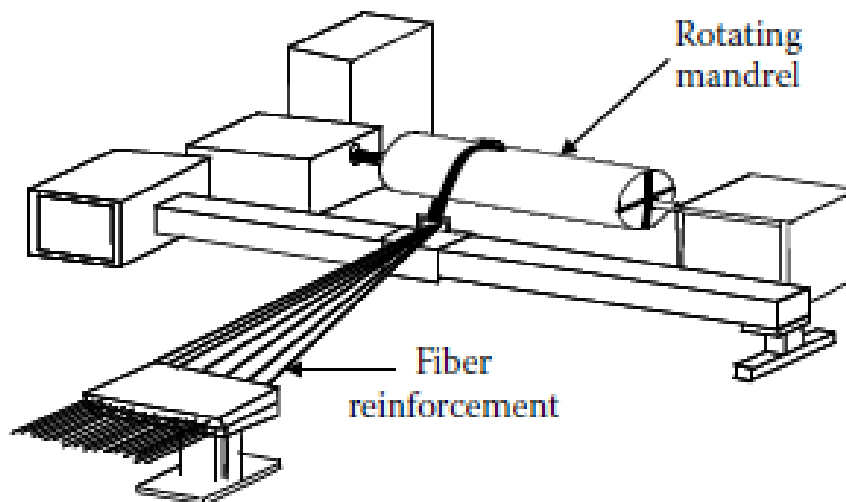
The process of filament winding involves the wrapping of many continuous strands of fiber or continuous mats around a mandrel. The mandrel is made from one of several different materials, such as plywood, aluminum, and steel. Once again, the fibers are wetted by being run through a resin bath prior to wrapping around the mandrel. The member is then cured through the application of heat lamps or by being fed through an oven. Once curing is initiated, shrink-wraps are employed to minimize voids. Shrink wrap is a flexible, thin plastic that is wrapped around the specimen to provide uniform pressure. The wrap is removed after the curing has finished. A key advantage provided by filament winding is the ability of the process to produce a fabric architecture with fibers running in the magic angle. That is to say that fibers run at plus/minus 54 degrees. This angle is the optimum angle for pipes because the combination of hoop stress and longitudinal stress, created by internal pressures, act along this angle (GangaRao et al. 2007). **Error! Reference source not found.** below shows a typical filament-winding machine.

Figure 2-2: Filament Winding Machine

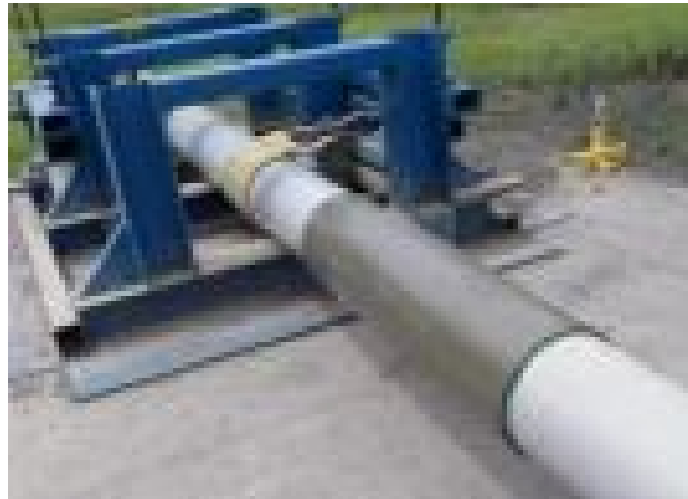
Corporation in the fall of 2016. In turn, Kenway manufactured 2, 24 inch long pipes, joined by a 12 inch filament wound sleeve. The joint was tested under hydrostatic pressure and failed at the edge of the joint near 1000 psi. Since the joint is the controlling factor for pipeline integrity, redesign is necessary so that burst pressures of the joint exceed burst pressures of the pipe specimens themselves. **Error! Reference source not found.** below shows a filament wound sleeve joint, which was produced by Kenway Corporation.

Figure 2-4: Filament Wound Sleeve Joint

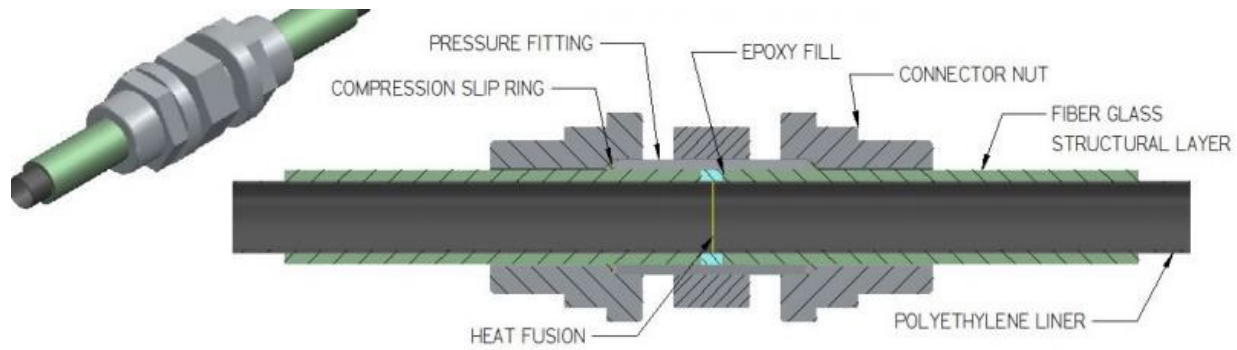
The second type of joint under consideration is known as a heat fusion joint. The idea for this joint by was suggested by research being done at the Savannah River National Laboratory (non-proprietary). Heat fusion jointing is a welding process for the joining of polyethylene pipe. In this process, two pieces of pipe are heated at the same time and pressed together. As the pipes cool, the curing process forms a permeant bond. (Rawls 2014). At this point, very little work has been done to evaluate this joint. Once again, design and testing of this joint will take place during the second half of phase 2 of the project. **Error! Reference source not found.** shows the joint with liners, fillers, and mechanical connectors.

Figure 2-5: Heat Fusion Joint

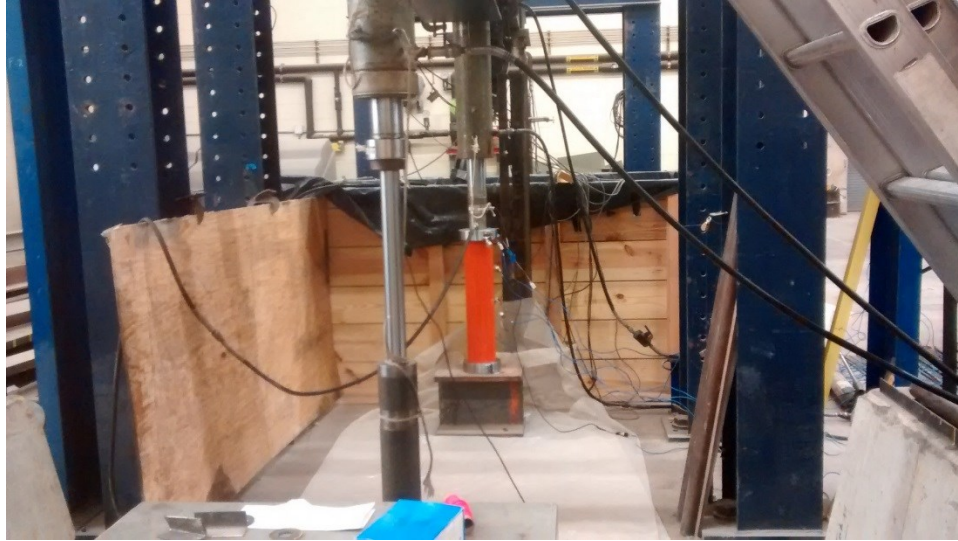
The first pressure test conducted took place in the Fall of 2016. The test specimen was an orange, 24" long pultruded pipe with a 6" outer diameter and a wall thickness of 1/4" inch. This test was primarily intended as a preliminary test. The pipe specimen, which was manufactured by Creative Pultrusion, was already on hand and was of appropriate size for a low pressure test. One key issue associated with pressure testing of FRP pipes pertains to the endcaps. Most steel pipes simply have endcaps welded on, however, it is not possible to weld or bond FRP endcaps to FRP pipes, at least not in a way that can resist several hundred thousand pounds of resultant force. Therefore, the project team decided to utilize steel endcaps and an external load resisting system. **Error! Reference source not found.** shows this load system configured for the pultruded pipe.

Figure 2-6: Load Resisting System

The test system is comprised of two main components, a pressure cylinder and the pressurized pipe. Load is applied, through an actuator, to a steel rod which compresses a small amount of water, seen in the foreground of **Error! Reference source not found..** As the pressure cylinder is loaded, the pressure flows through small hydraulic lines into the endcap of the pipe, seen in the background of **Error! Reference source not found..** An actuator above the pipe presses down on the endcap and prevents it from advancing off the end of the pipe. This pipe failed under 1000 psi in an unzipping fashion, breaking down the length of the pipe. This test allowed the project team to conclude that the test method adopted was acceptable.

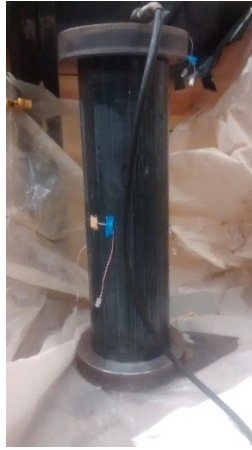
The second set of tests was conducted in Spring of 2017. The specimens for this test were 36 inch long piles with outer diameter of 10 inches and a thickness of 3/8 inches. While piles, are very poorly suited for pressure applications, the team wanted to test the system for larger diameter pipe which would resist higher resultant loads. The same test methodology was used as stated earlier. These pipes failed either by unzipping along the pipe length or by expanding to the point that water began to seep through the walls (weeping). **Error! Reference source not found.** shows the pultruded pile fitted with the 10 inch diameter end caps.

Figure 2-7: Pultruded Pile

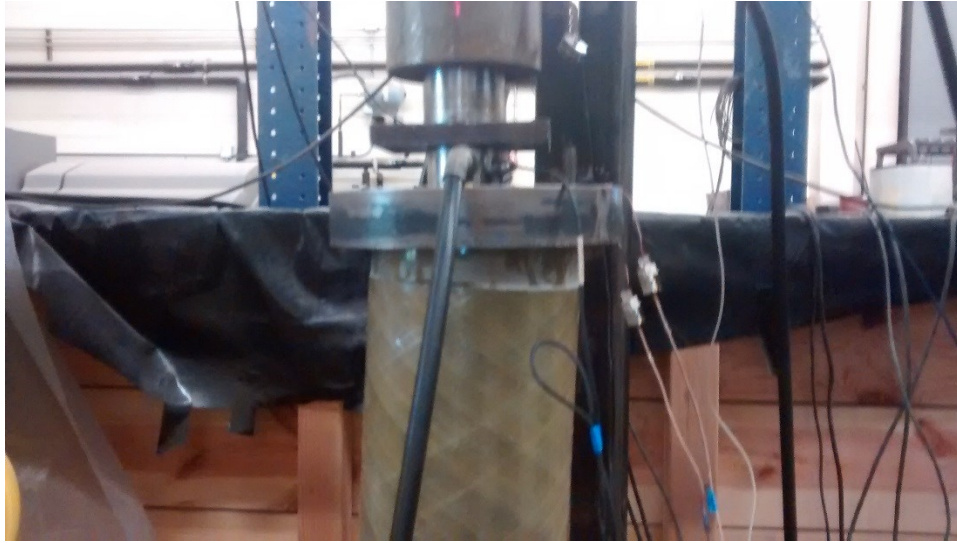
These piles failed under pressures near 300 psi. While these values are very low, the result was expected because piles have very little reinforcement in the hoop direction. Once again, the test methodology was found to be successful. However, the team did make a very important observation. During testing, eccentricities in the load frame resulted in the endcap rotation. This eccentricity was caused during the test preparation. If the center of the pipe (the center of pressure) was not placed directly under the center of the actuator (center of resistance), even by a fraction of an inch, the high resultant force combined with the small moment arm would cause the system to bend. This meant that the end cap was not restrained sufficiently by the relatively small diameter actuator. When the endcaps were poorly restrained, the rotation would cause the piles to leak before reaching any sort of failure. The cap would be forced onto one side, leading to crushing of the composite, while being lifted from the other side. To address this issue, the load frame was lowered and the actuator was shortened, thereby reducing the eccentricities and increasing the area of resistance. **Error! Reference source not found.** shows the eccentricity of the actuator and the endcap rotation.

Figure 2-8: Eccentricity and Endcap Rotation

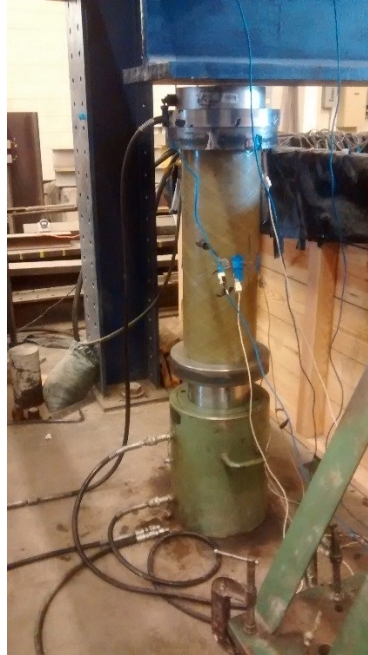
The third set of tests was conducted took place in April Spring of 2017. These specimens were 36 inch long, filament wound pipes, with a 10 inch outer diameter and a thickness of $\frac{1}{4}$ inch. These pipes were provided by Kenway Corporation. **Error! Reference source not found.** shows the filament wound pipe in the modified load frame. As can be seen, the frame is much lower to the ground and a much thicker actuator has been used. The combination of these two adjustments allowed the pipe to reach much higher internal pressures before leaking.

Figure 2-9: Filament Wound Pipe

These pipes were tested several times and have yet to fail, although the tests have been ended several times either due to premature leakage at the endcaps or due to limitations in the load frame. At this point, the pipes have withstood pressures up to 2300 psi, without failure. Due to limitations in the frame, a new load frame has been designed and is under fabrication. The project team hopes to proceed with testing during Fall of 2017 as a part of another USDOT-PHMSA funded project (Gangarao et al. 2016).

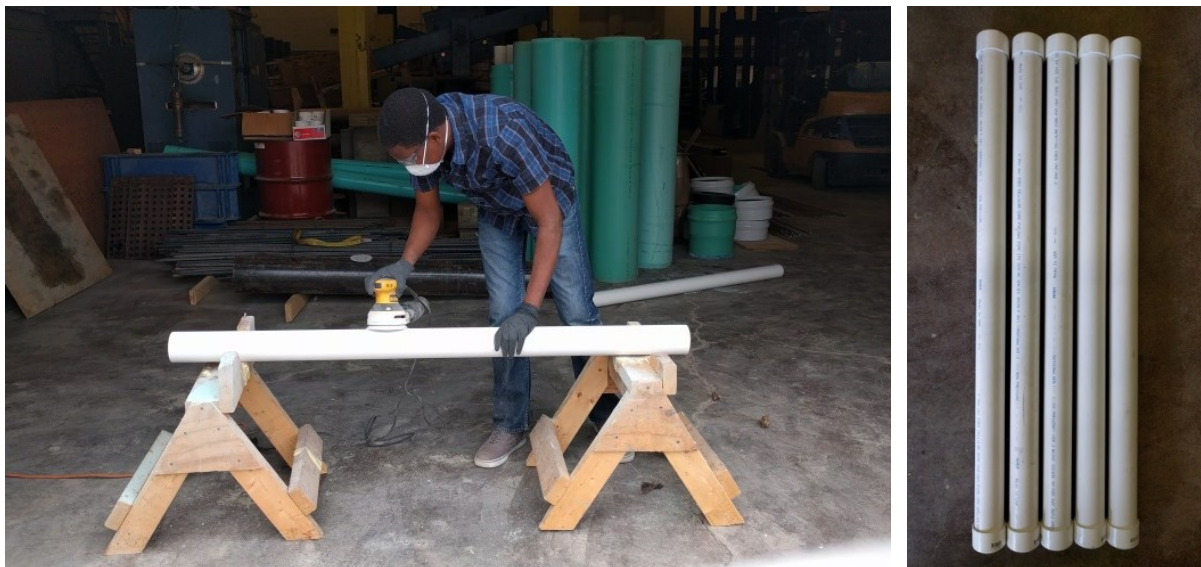
Figure 3-2: The 3" diameter PVC pipes

Similar to the 12" diameter PVC pipes, 14 ft. long SDR-35 and 10 ft. long schedule 40 (SCH 40) pipes were cut to obtain the 5 ft. long 6" and 3" diameter pipe samples respectively. The 6" and 3" diameter pipes were also capped, and the surfaces of some of them were grinded to enable adequate bonding with GFRP and CFRP fabric (Figure 3-2).

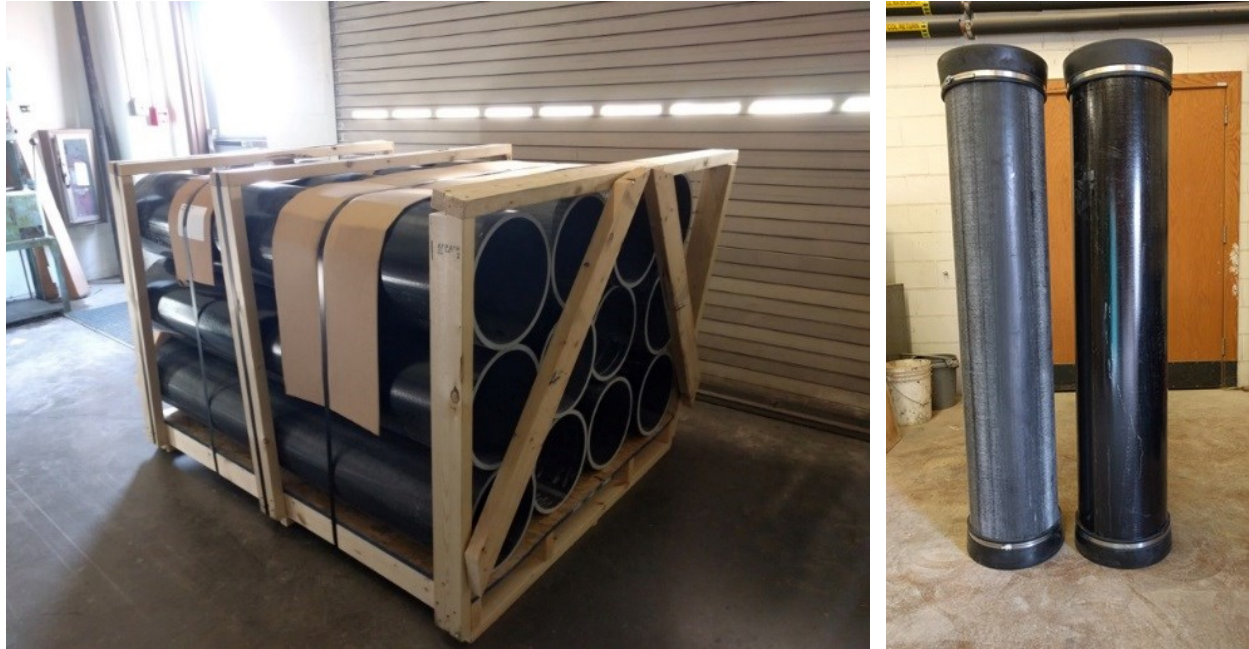
(a) GFRP pipes from the manufacturer

(b) Capped pipes

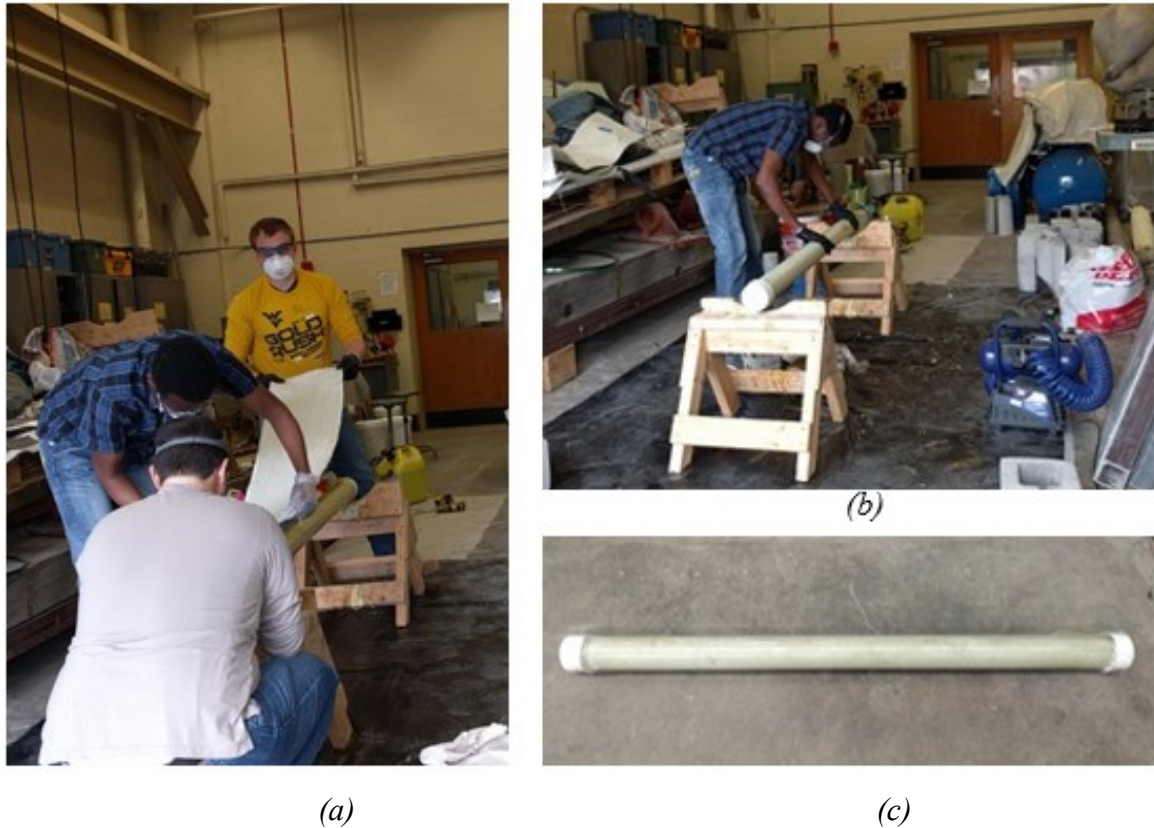
The 3" diameter GFRP pipes for the study were manufactured in the WVU Constructed Facilities Center (CFC) by wrapping two layers of 24 oz. biaxial (0/90) stitched GFRP fabric around 3" diameter PVC pipes (the PVC pipes serving as molds in this process). This increased the outside diameter of the GFRP pipes above the standard 3" PVC pipe dimension. Details of the GFRP fabric and the resin (matrix) system used in manufacturing the 3" GFRP pipe is shown in Table 3-1. The manufacturing process and a completed GFRP pipe are illustrated in Figure 3-4.

Figure 3-4: 3" diameter GFRP pipes (a), (b) manufacturing process, and (c) a completed pipe

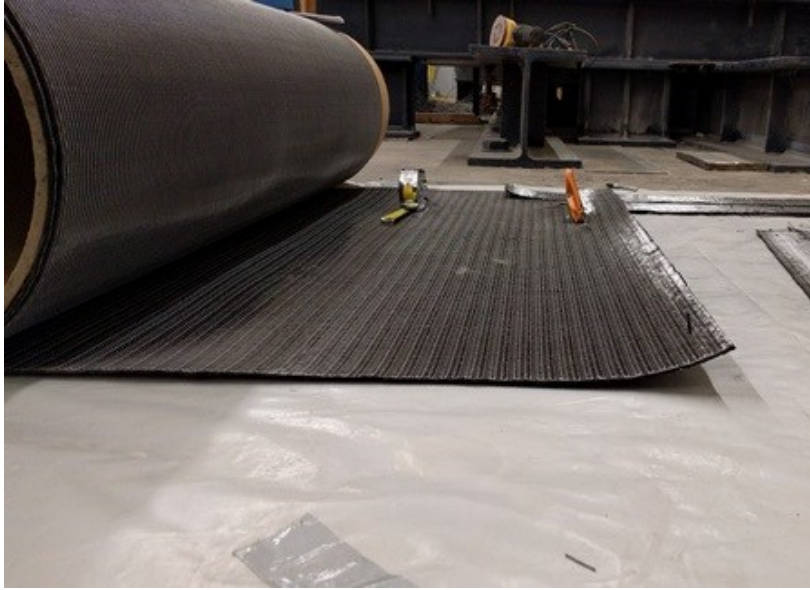
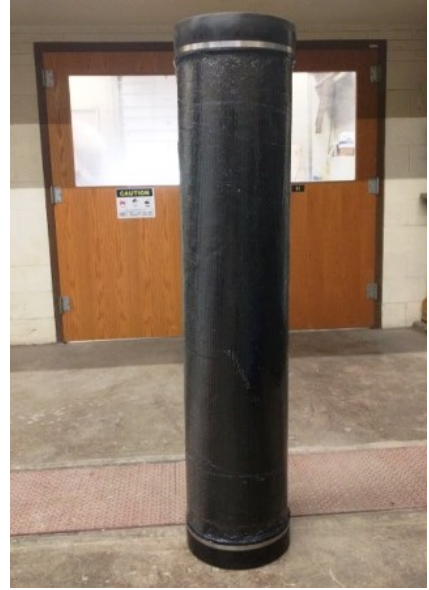
(a) Roll of CFRP fabric

(b) The completed pipe

Figure 3-5: 12" diameter CFRP pipe

The 12" diameter CFRP pipe used in this study was also fabricated in the WVU Constructed Facilities Center (CFC) by wrapping two layers of quad-axial (0/90/±45) stitched CFRP fabric around a 12" diameter cardboard tube (the cardboard tube served as a mold in this process). Details of the CFRP fabric and the resin system used in manufacturing the 12" CFRP pipe is shown in Table 3-1. The pipe was finally capped to keep ground water out of it after burying. Figures 3-5(a) and 3-5(b) show the CFRP fabric and the completed 12" diameter CFRP pipe respectively

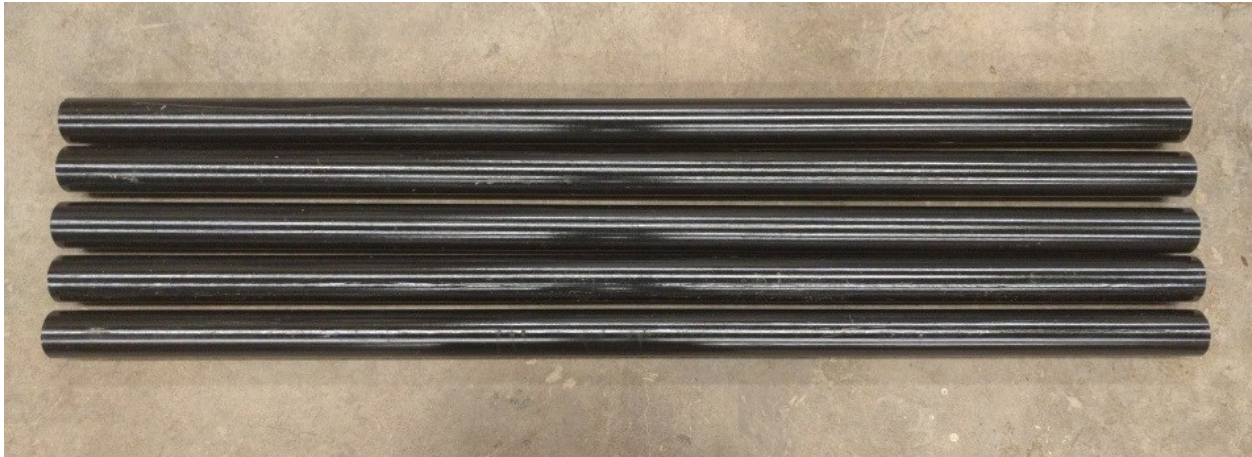
Figure 3-6: The 3" diameter CFRP pipes

The 3" diameter CFRP pipes used in this study were supplied by the manufacturer in 6 ft. long segments (Figure 3-6). The pipes were first cut into 5 ft. long segments to keep the lengths consistent with the other pipes, they were then capped to keep ground water out of them after burying.

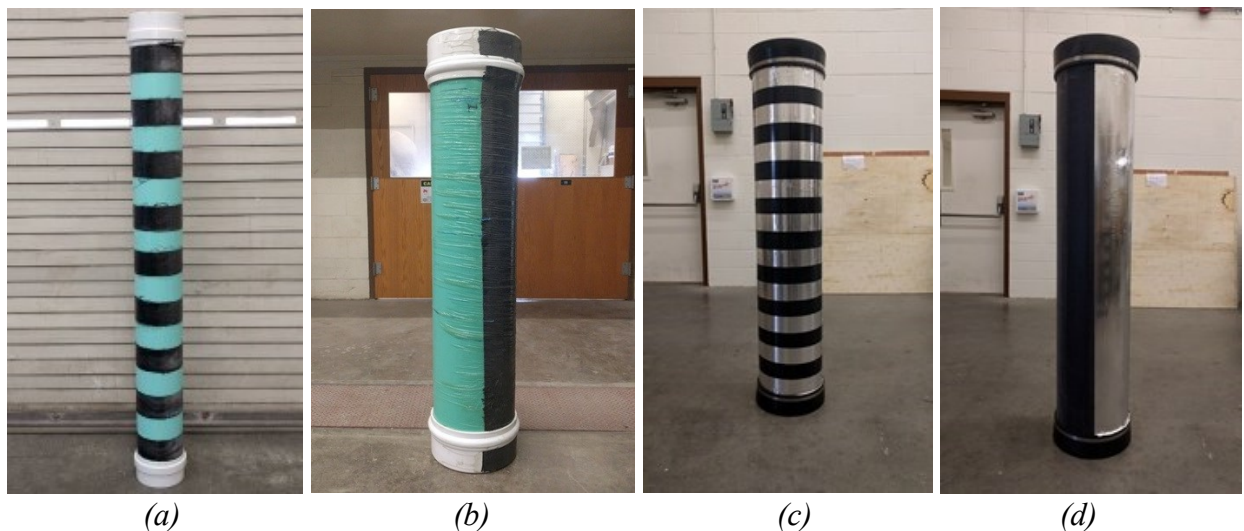
Some of the PVC and GFRP pipes were wrapped with CFRP fabric and aluminum tapes, in the form of rings and strips to improve GPR detectability of these pipes. The carbon fabric and aluminum rings are 3" wide, and placed at 3" clear spacing while the carbon fabric strip and aluminum strips covered half of the pipe circumference and stretched the full length of the pipes (excluding pipe caps in most cases). Some of the wrapped pipes are shown in Figure 3-7. Some of the PVC and GFRP pipes were not wrapped (these are labelled as "Unwrapped" in Figure 3-9), and were used as control specimens during GPR detectability testing of the samples.

Figure 3-7: Completed (wrapped) pipes: (a) 6" diameter PVC with carbon fabric rings, (b) 12" diameter PVC with carbon fabric strip, (c) 12" diameter GFRP with aluminum rings, and (d) 12" diameter GFRP with aluminum strip

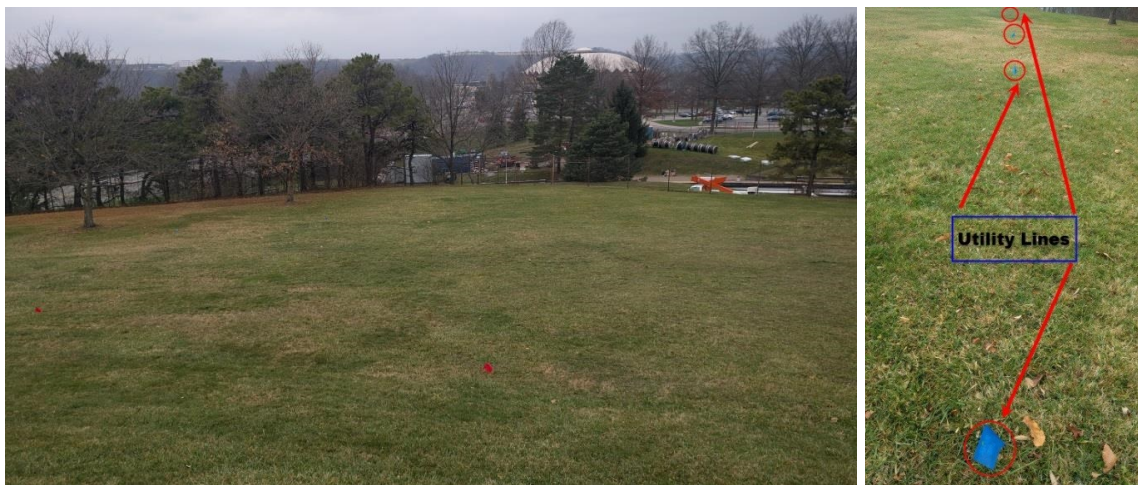
Figure 3-8: The located site within WVU campus for burying the pipes

Pipe specimens prepared for GPR testing were buried at a site located on the WVU campus. Utility lines close to the allocated site were first marked to prevent excavation damage of the lines during pipe burying. The site and the marked utility lines are shown in Figure 3-8.

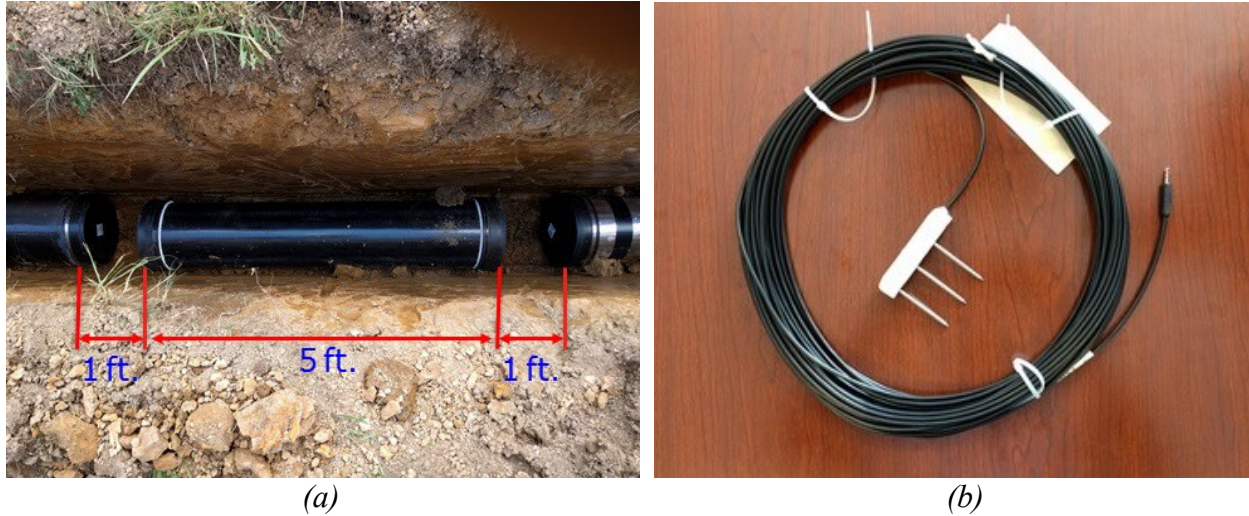
Figure 3-10: (a) Arrangement of pipes in the trench, (b) soil moisture and resistivity sensor

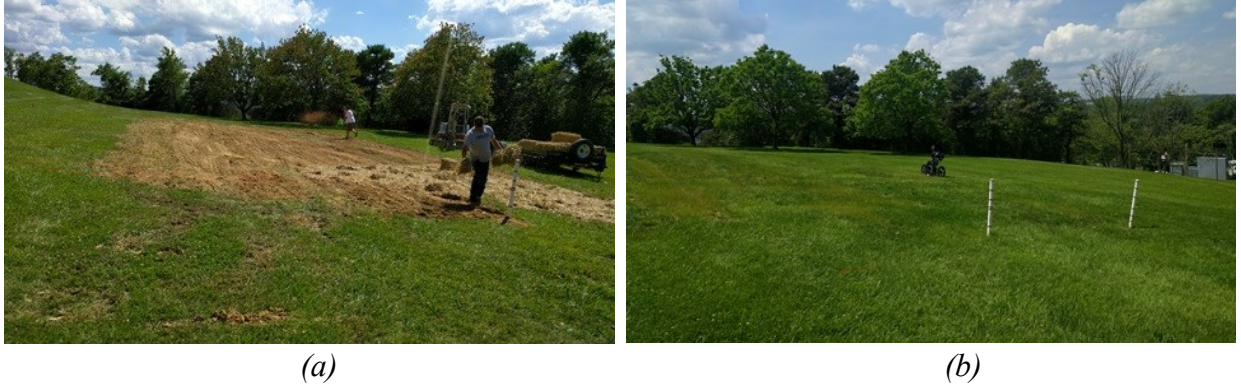
Figure 3-12: (a) The site being seeded, (b) the field restored to initial condition

Finally, the trenches were backfilled, the ground surface was levelled and then seeded with grass (Figure 3-12) to restore the initial field condition before GPR testing.

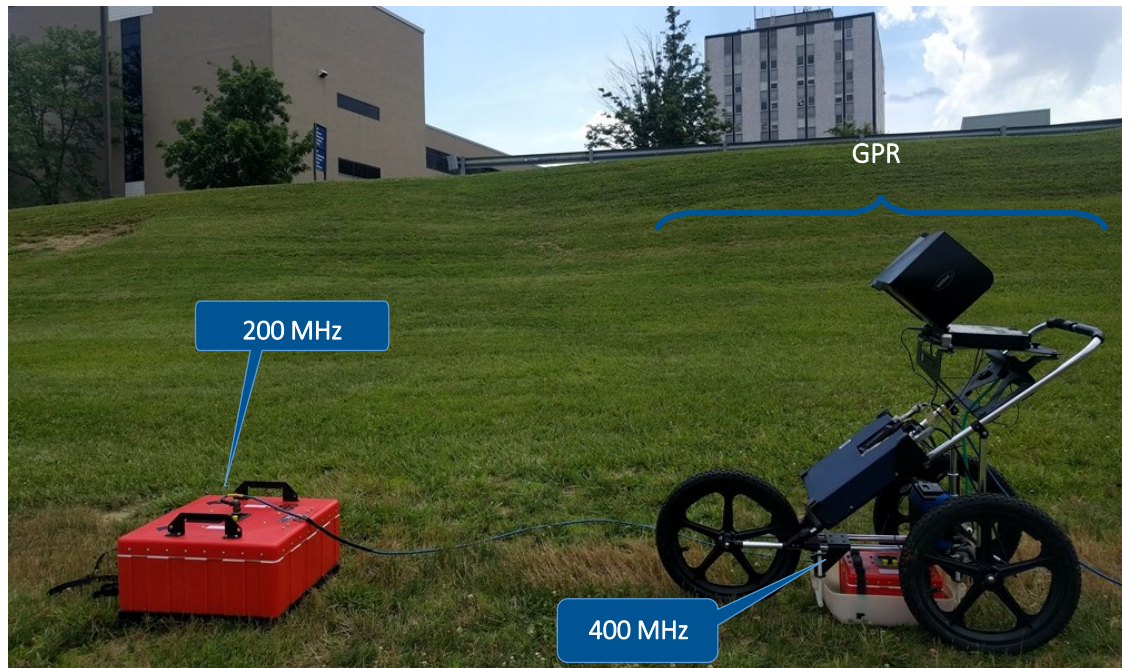
The GPR system used in this study was the SIR-20 model manufactured by Geophysical Survey Systems, Inc (GSSI). A 200 MHz antenna with a specified penetration depth of up to 30 ft. (in dry sand) and a 400 MHz antenna with a specified penetration depth of up to 12 ft. (in dry sand) were evaluated with this system. The quoted penetration depths depends on the complex dielectric permittivity of the soil medium, and therefore can be significantly lower in soils with high moisture contents and high clay content. The GPR system and antennae used in this study are shown in Figure 4-1.

Figure 4-1: SIR-20 GPR system and antennae used for testing

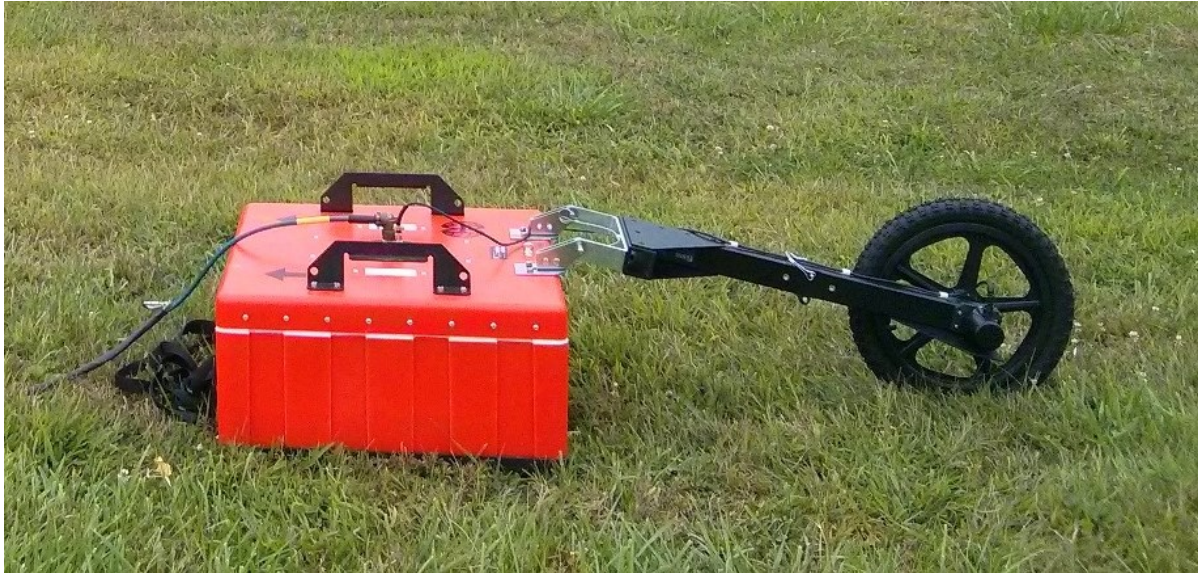
The GPR system has survey wheels with optical encoder for tracking horizontal distance along the ground surface. A survey wheel attached to the GPR cart is used to track distance when the 400 MHz antenna is used, while the 200 MHz antenna has a survey wheel attached to the antenna for horizontal distance measurement as shown in Figure 4-2.

Figure 4-2: 200 MHz GPR antenna with survey wheel

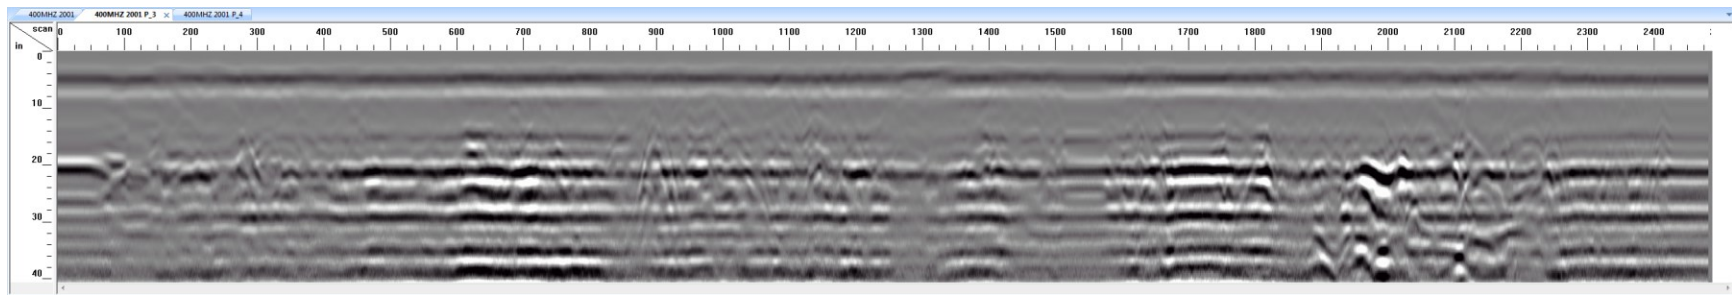
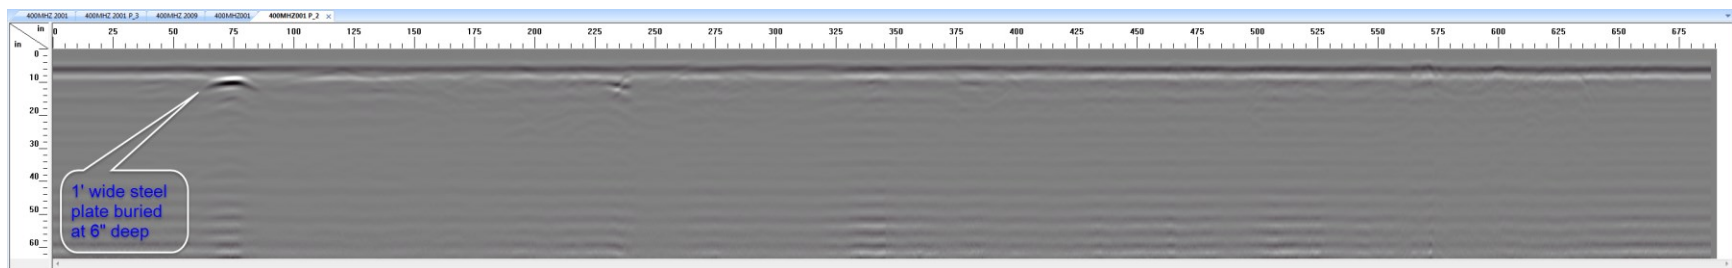
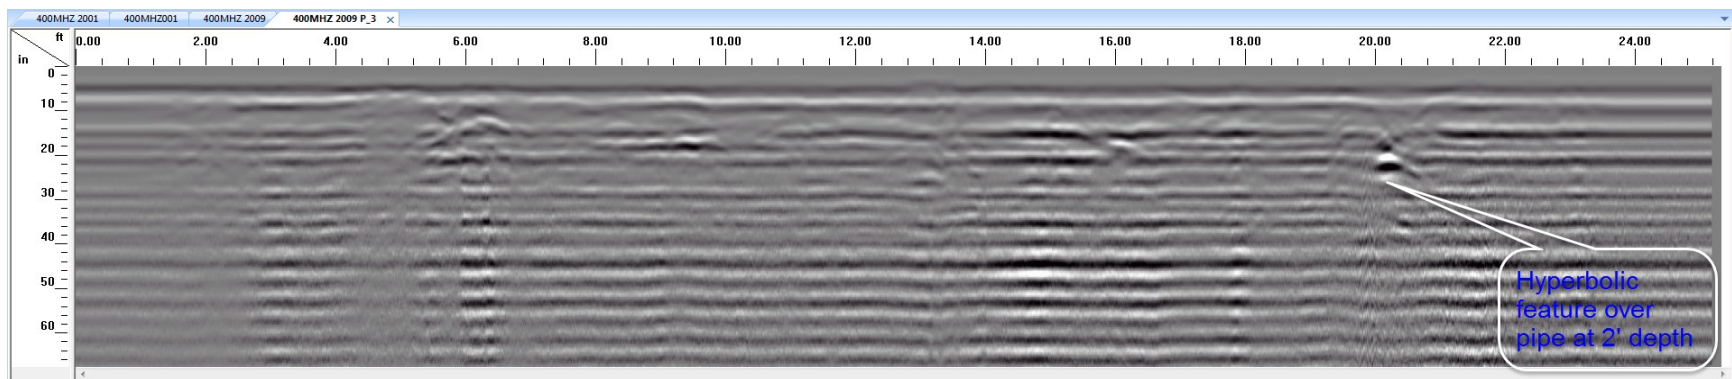
(a) Longitudinal scan along the full length of 3" diameter pipes with 2 ft. of soil cover

(b) Longitudinal scan along the full length of 12" and 6" diameter pipes with 3 ft. of soil cover

(c) Transverse scan across all the 3 trenches, from the 3 ft. deep to the 2 ft. deep one

Figure 4-3: Longitudinal and transverse scans over the trenches using 400 MHz GPR antenna

Multiple GPR scans were carried out in both the longitudinal direction along the trenches, and transverse direction across the pipe/trenches. All the trenches were scanned with both the 200 MHz and 400 MHz antennae, and some of the data obtained are shown in the following figures (Figures 4-3 through 4-22). Figures 4-3 and 4-4 show some of the data from longitudinal and transvers scans over the trenches using a 400 MHz antenna (this data is named “Dataset I”). Average soil dielectric constant for the data in Figures 4-3 and 4-4 were 19.75 and 21.65 for up to a depth of 2 ft. and 4 ft. respectively. Dielectric constants for this dataset, together with other datasets are summarized in Table 4-1. The 400 MHz antenna was able to locate most of the pipes located at 2 ft. depth. Signals from this antenna are particularly good over pipes with CFRP fabric wraps/overlays as shown in Figure 4-4 (a) and (b). The 400 MHz antenna was however not able to locate any of the pipes buried below 2 ft. of soil cover as can be seen from Figure 4-3(b) for 3 ft. of soil cover. The remainder of this chapter will focus on data obtained from the deeper penetrating 200 MHz antenna.

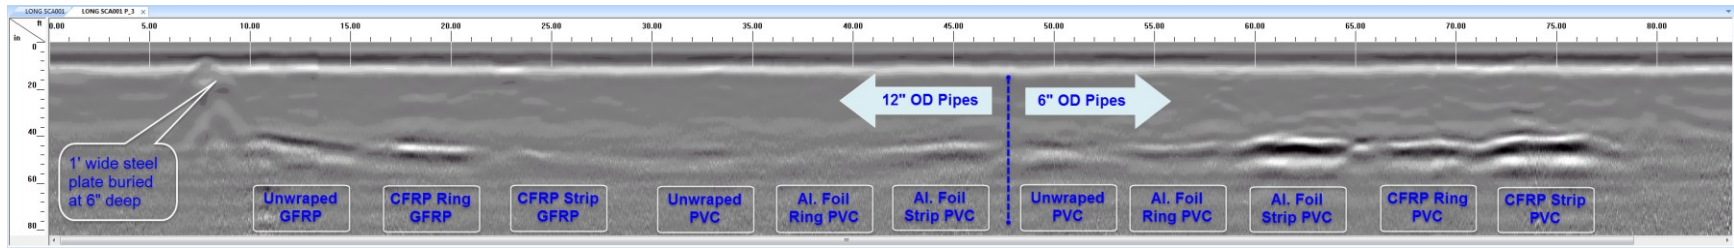
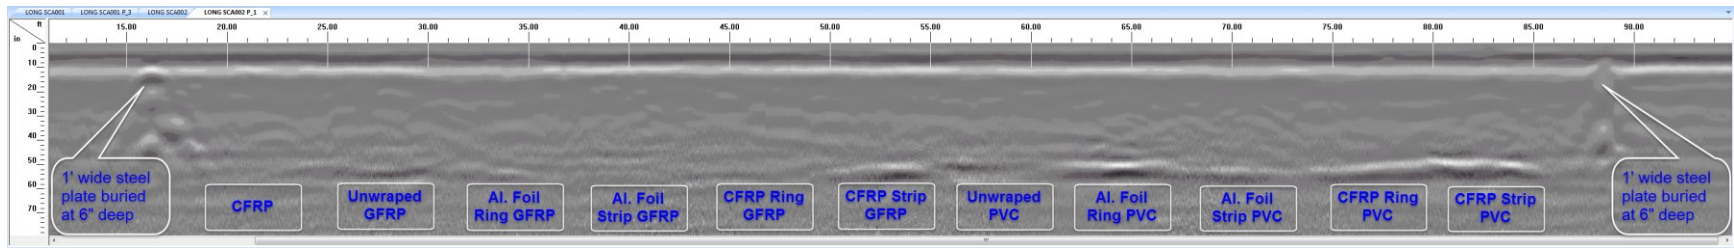
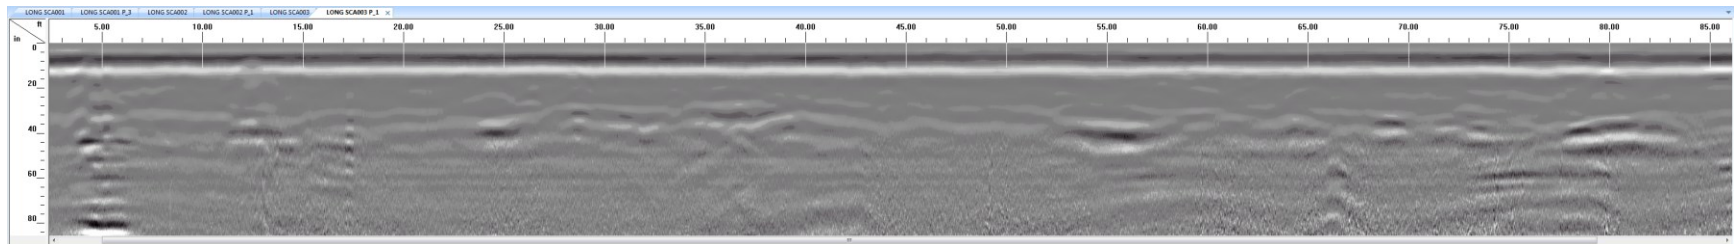
(a) Longitudinal scan along the full length of 12" and 6" diameter pipes with 3 ft. of soil cover

(b) Longitudinal scan along the full length of 12" diameter pipes with 4 ft. of soil cover

(c) Longitudinal scan along the full length of 3" diameter pipes with 2 ft. of soil cover

Figure 4-5: Dataset II - Longitudinal scans along the full length pipe trenches using 200 MHz GPR antenna

It is observed from Dataset II (Figures 4-5 through 4-8) that, aluminum foil and carbon fabric wraps/overlay on the pipe sections improve detectability with GPR. It is also observed that, aluminum strips and carbon fabric strips along the full length of the pipe sections produce better results compared to aluminum rings and carbon fabric rings.

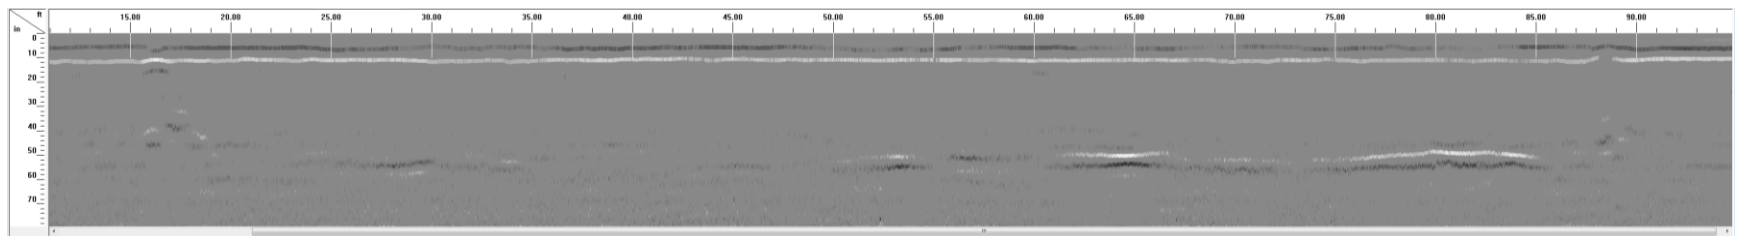
(b) Processed longitudinal scan using peak extraction to make pipe sections more visible

Figure 4-7: Dataset II - Longitudinal scan and the processed data along the full length of 4 ft. deep trench

It can also be seen in Figures 4-7(b) and 4-10(b) – data from the 4 ft. deep trench – that the following pipe sections, CFRP, Al. Foil Ring GFRP, Al. Strip GFRP, and CFRP Ring GFRP, which were not visible in Dataset II are visible in Dataset III. The visibility of the other pipes in this 4 ft. deep trench has also been significantly improved in Dataset III.

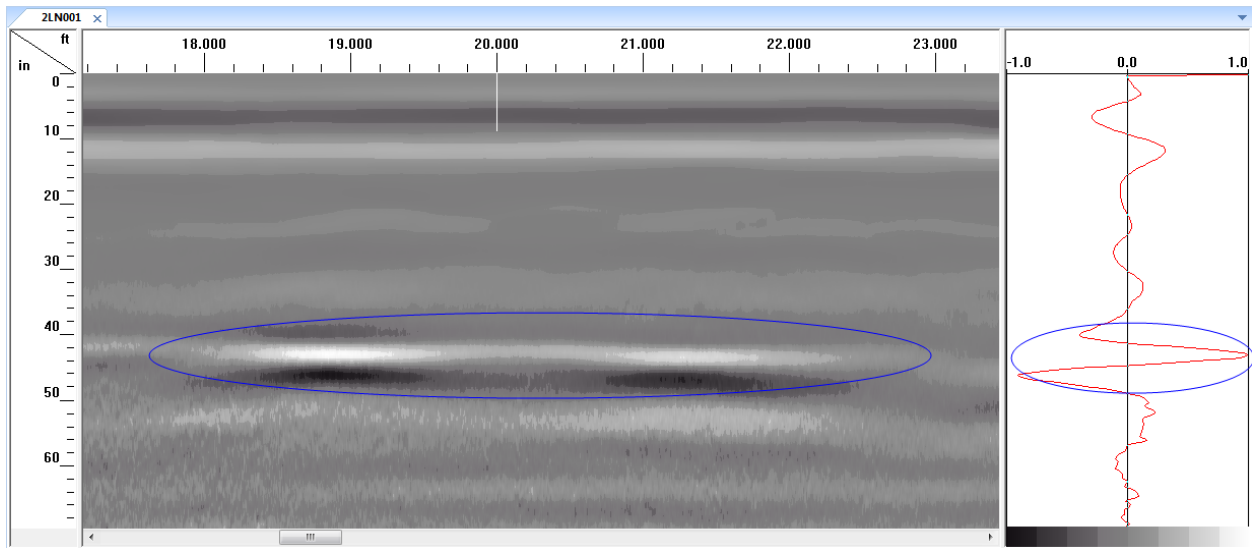
Figure 4-13: Longitudinal GPR scan (left) and A-Scan (right) over 12" CFRP Ring GFRP pipe

Figures 4-13 and 4-14 above show that the 12" diameter GFRP pipe with CFRP Ring or Strip show up prominently in the GPR scan.

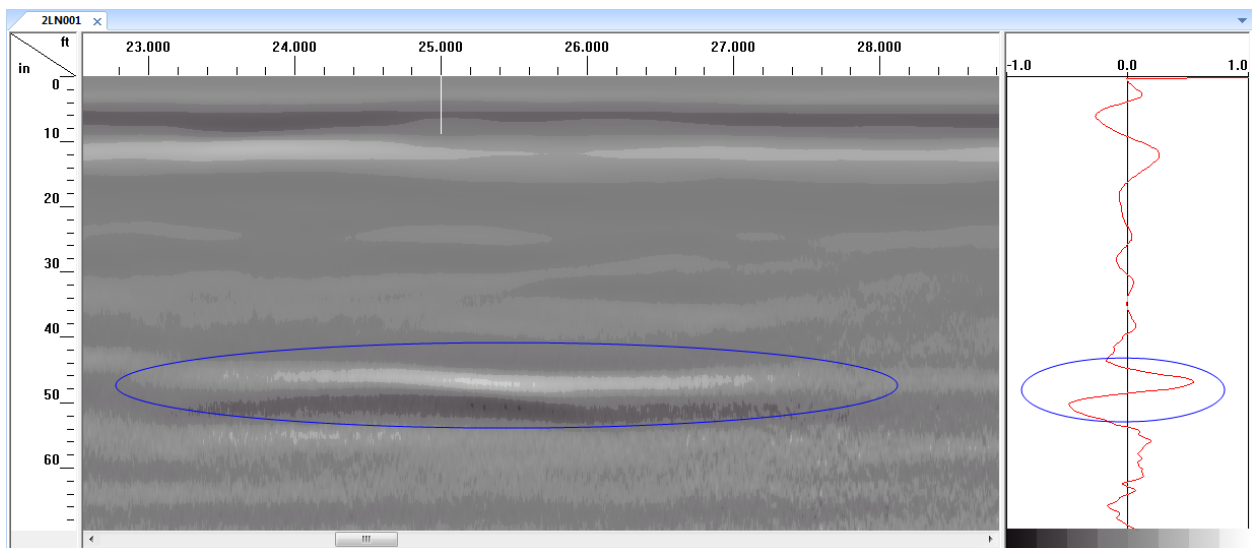
Figure 4-14: Longitudinal GPR scan (left) and A-Scan (right) over 12" CFRP Strip GFRP pipe

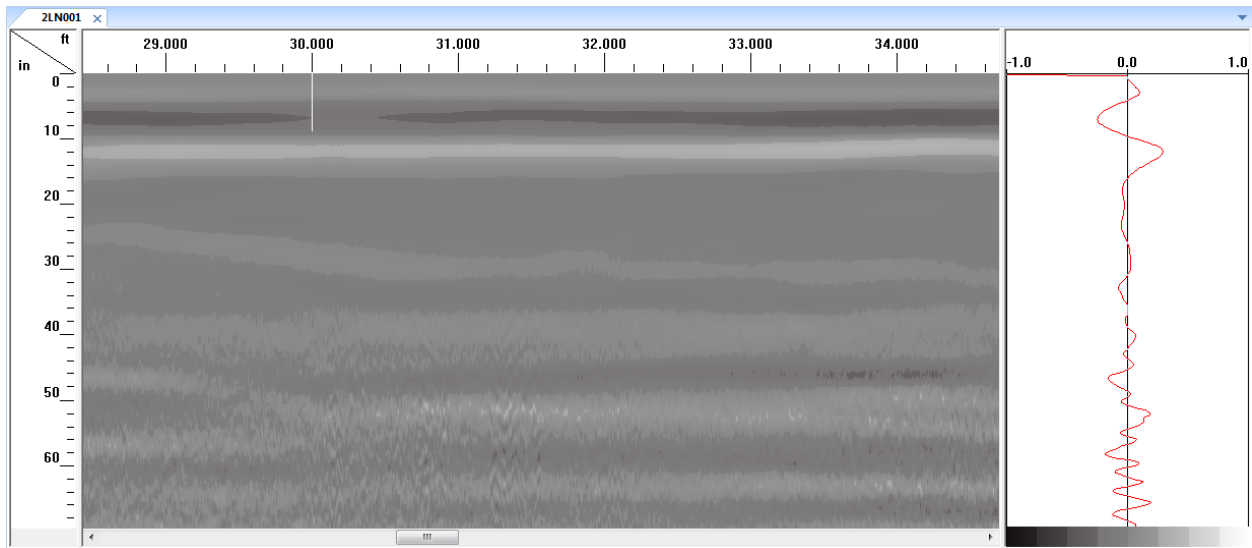
Figure 4-15: Longitudinal GPR scan (left) and A-Scan (right) over Unwrapped 12" PVC pipe

The Unwrapped 12" diameter PVC pipe buried at 3 ft. depth was not visible in raw image (Figure 4-15), but has a better visibility in processed image as shown earlier in Figure 4-9.

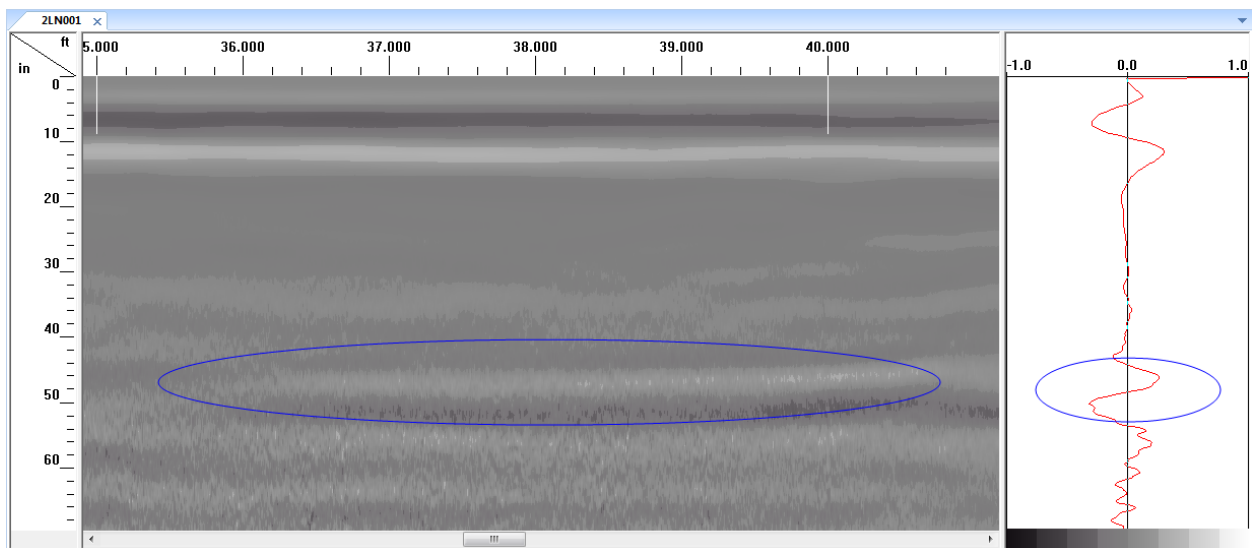
Figure 4-16: Longitudinal GPR scan (left) and A-Scan (right) over Al. Foil Ring 12" PVC pipe

The 12" diameter PVC pipe wrapped with Al. Foil Ring was only slightly visible in the raw image (Figure 4-16), but with a better visibility in processed image as shown earlier in Figure 4-9. The corresponding pipe with Al. Foil Strip (Figure 4-17) shows a more prominent GPR signal.

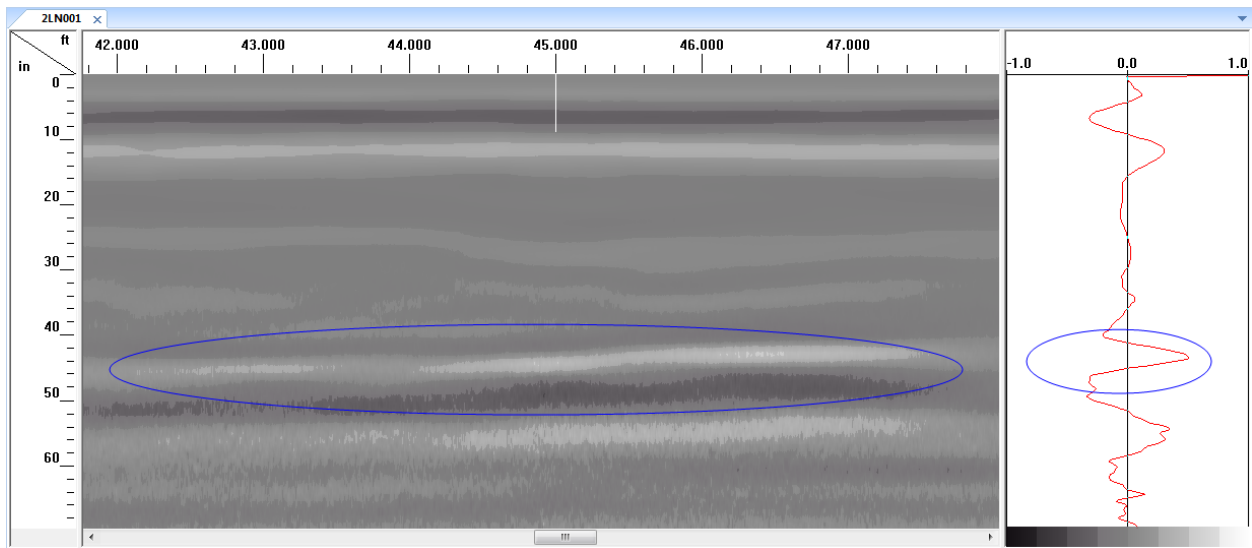
Figure 4-17: Longitudinal GPR scan (left) and A-Scan (right) over Al. Foil Strip 12" PVC pipe

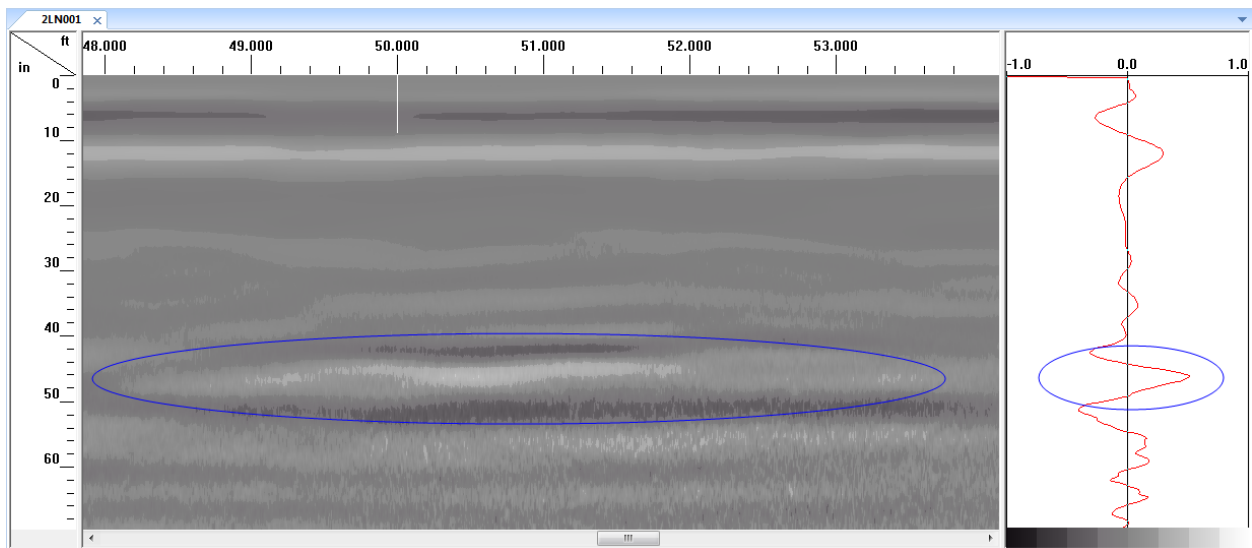
Figure 4-18: Longitudinal GPR scan (left) and A-Scan (right) over Unwrapped 6" PVC pipe

A comparison of GPR signals between the three cases of 6" diameter PVC pipes (unwrapped, and with aluminum foil ring or strip) shown in Figures 4-18, 4-19, and 4-20 indicates that the PVC pipe with the Aluminum Foil Strip on the top is the most prominently detectable configuration as indicated by the high strength of GPR signal in the A-scan in Figure 4-20.
